CASE STUDY

Planned Maintenance Works

Property:
Multi Let Industrial Warehouse

Location:
Gatwick Business Park, East Sussex

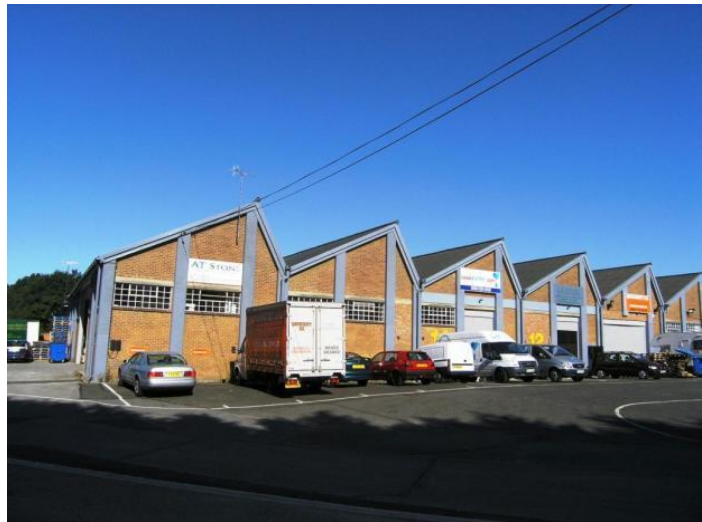
Alexander Harris was originally appointed to undertake an inspection of this substantial multi-let industrial warehouse and report on the likely cause of high level water ingress. Our investigation identified corrosion of the metal liner to the valley gutters of the likely cause, together with poor quality repairs undertaken previously.

A number of repair options were assessed before opting for a proprietary fold-in lining system comprising a rubberised membrane factory bonded to a galvanised and coated steel substrate/liner. The system was chosen based on its durability, longevity and speed of installation.
